## MEMORANDUM FOR RECORD

**Subject:** NTSB investigation ERA19FA155, N9693E, Bellanca 17-30A, Henderson, Kentucky, April 23, 2019.

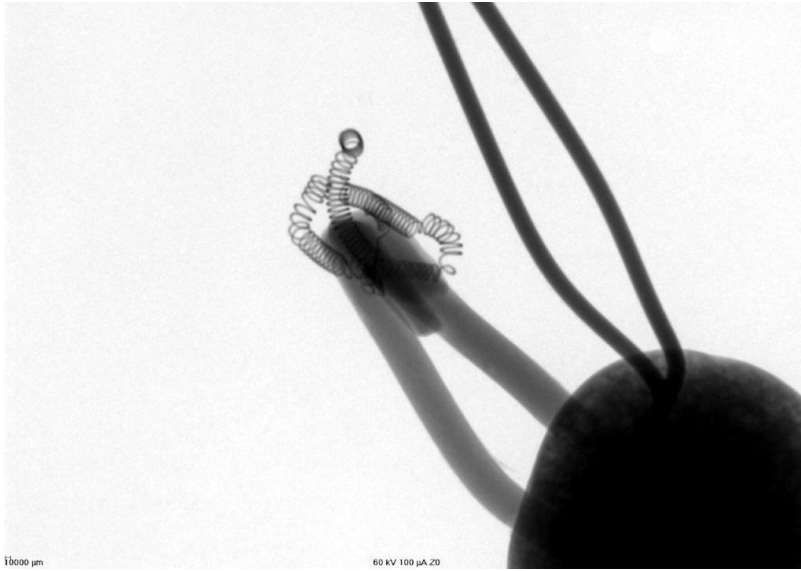
*Figure 1 - "AUX" Fuel Light Bulb*

*Three annunciator light bulbs were submitted to the Materials Laboratory to determine the condition of the filaments in each bulb. The bulbs were designatde "Right Fuel", "Aux Fuel" and "Left Fuel".<sup>1</sup> The bulbs were x-rayed to examine the status of the filaments of each bulb. The left and aux bulbs were damaged. The globes of both bulbs were broken. There was no filament present in the left fuel bulb. There was a small section of filament still attached to the posts of the aux fuel bulb. The filament showed evidence of stretching. However, due to the damage to the bulb, it could not be determined if the stretching was a result of hot filament stretching. The right fuel bulb was intact. The filament of the right bulb was also intact. The filament of the right bulb exhibited hot filament stretching.*
